River Dart Study

GCSE Geography River Study Analysis

Study Date: 15/09/2024

Location: Devon, UK

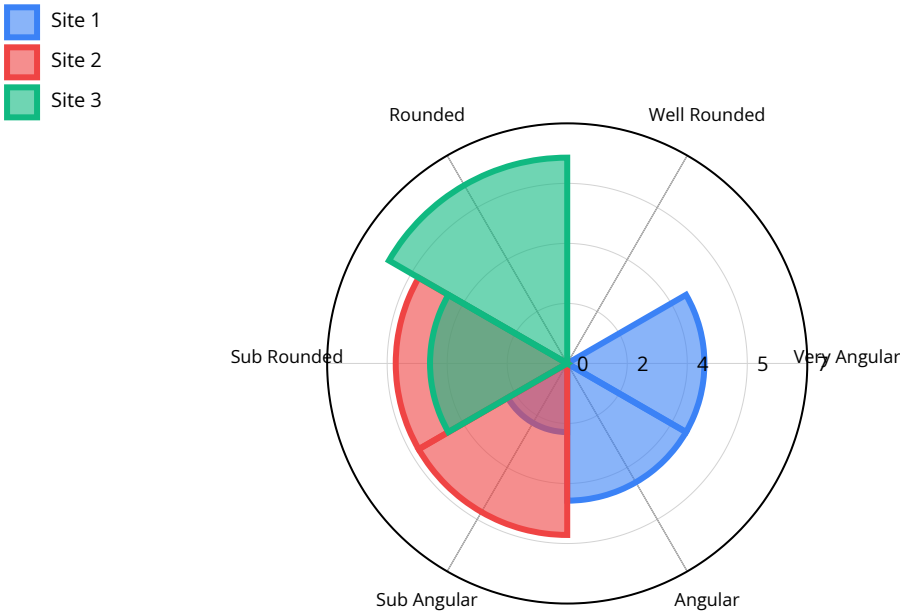
Figure 2: Wind rose chart showing sediment roundness distribution across all measurement sites

Measurement	Site 1	Site 2	Site 3	Summary
Sediment Size Average (mm)	44.80	29.60	15.50	29.97
Sediment Shape Average	1.80	3.50	4.60	3.30
Spearman's Rank Correlation	-0.927	0.794	0.855	0.240

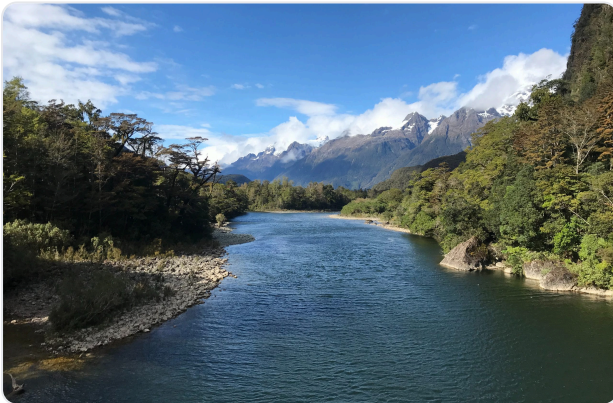
Primary Site Photo

Notes: Rocky riverbed with large granite boulders. Water very clear. Some small trout observed.

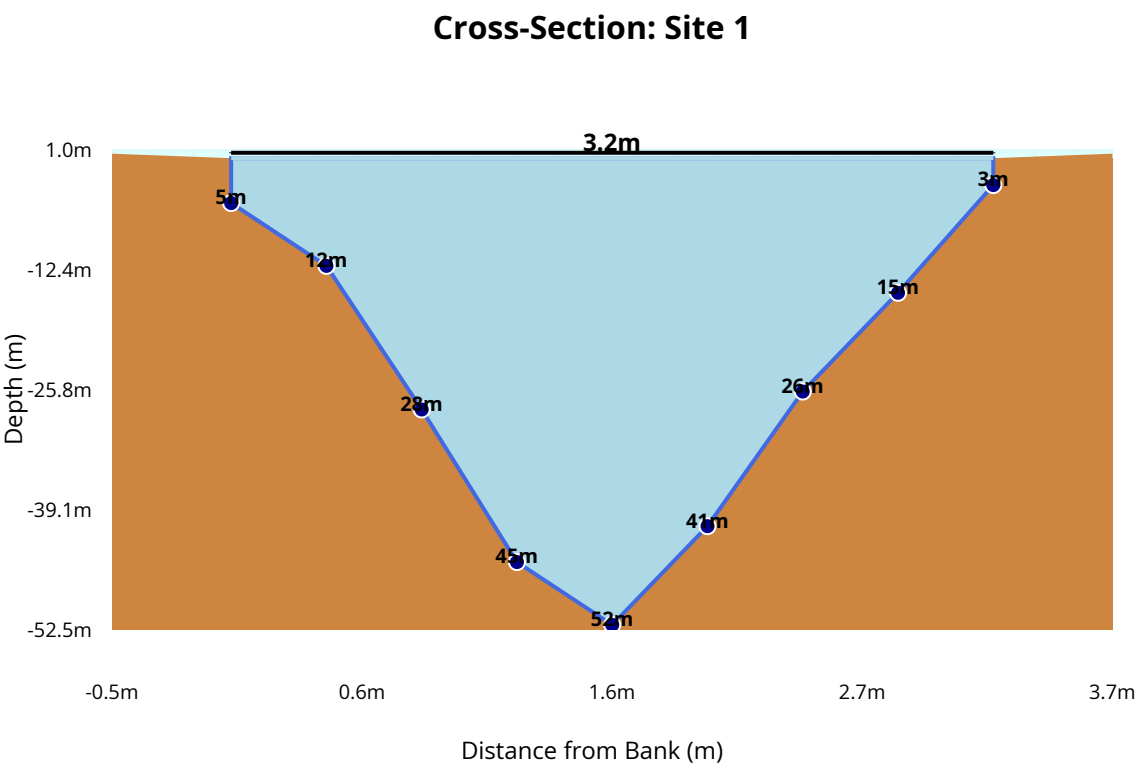
Figure 3: Cross-sectional profile for Site 1 showing depth measurements across river width

Point Number	Distance from Bank (m)	Depth (m)
1	0	5
2	0.4	12
3	0.8	28
4	1.2	45
5	1.6	52
6	2	41

Point Number	Distance from Bank (m)	Depth (m)
7	2.4	26
8	2.8	15
9	3.2	3

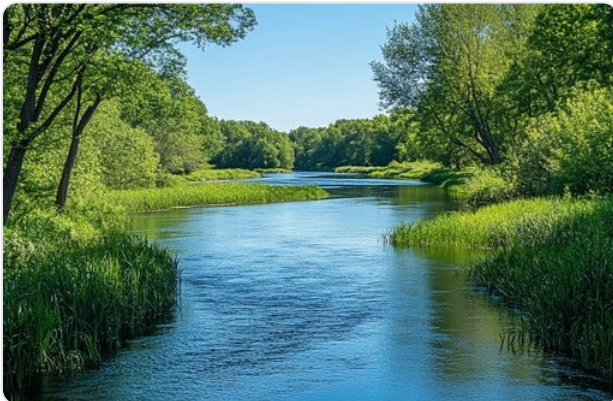
Primary Site Photo

Notes: Riverbed of mixed pebbles and sand. Some erosion on outer meander bends. Evidence of cattle access.

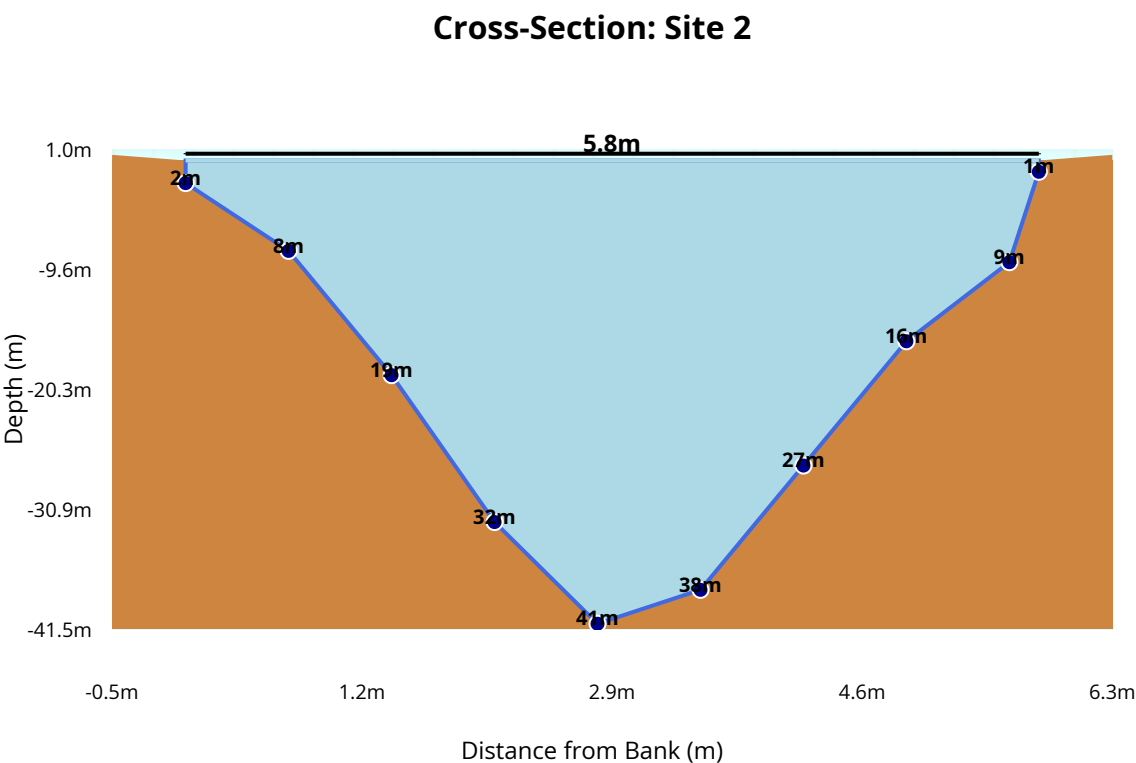
Figure 4: Cross-sectional profile for Site 2 showing depth measurements across river width

Point Number	Distance from Bank (m)	Depth (m)
1	0	2
2	0.7	8
3	1.4	19
4	2.1	32
5	2.8	41
6	3.5	38

Point Number	Distance from Bank (m)	Depth (m)
7	4.2	27
8	4.9	16
9	5.6	9
10	5.8	1

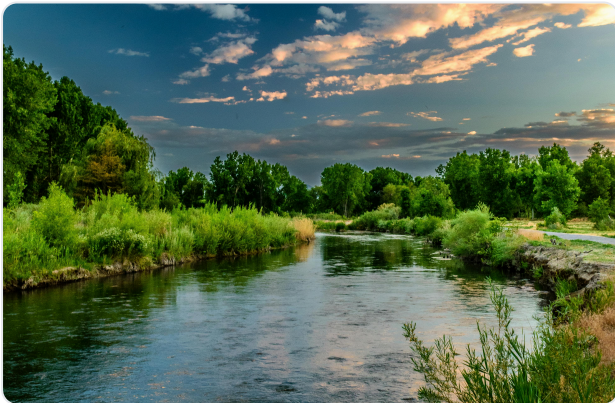
Primary Site Photo

Notes: Wider, slower flowing section. Muddy banks with vegetation. Some pollution from agricultural runoff evident.

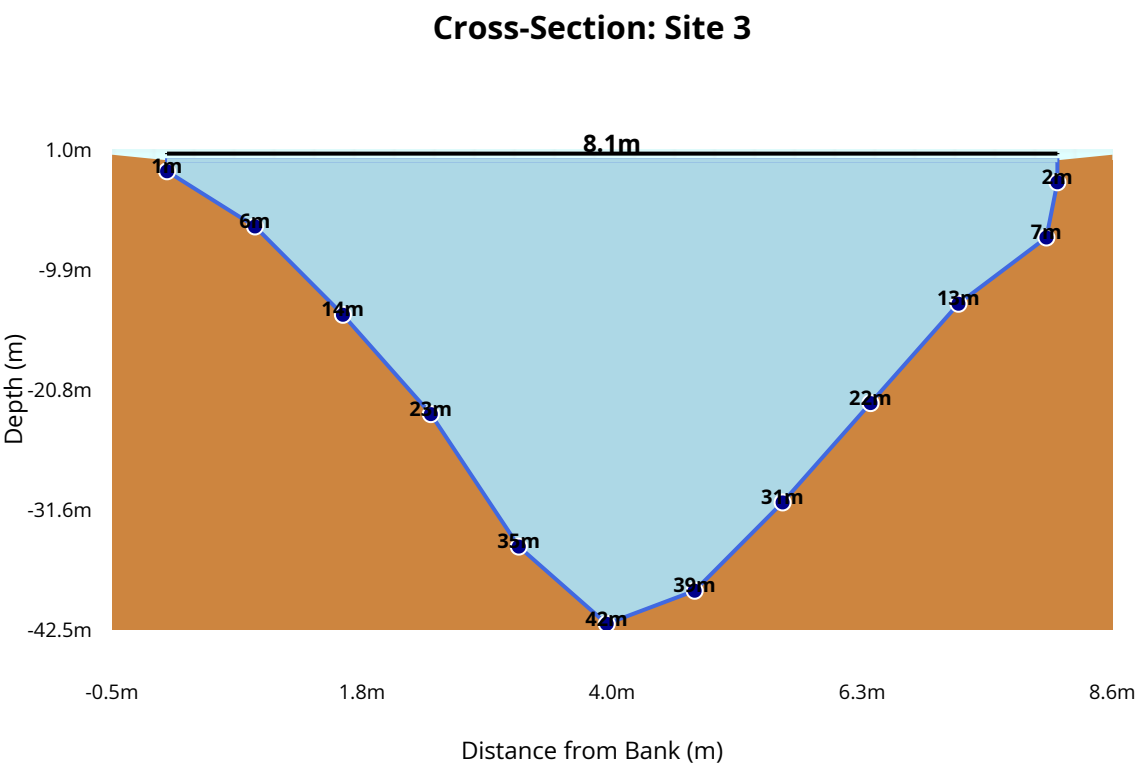
Figure 5: Cross-sectional profile for Site 3 showing depth measurements across river width

Point Number	Distance from Bank (m)	Depth (m)
1	0	1
2	0.8	6
3	1.6	14
4	2.4	23
5	3.2	35
6	4	42

Point Number	Distance from Bank (m)	Depth (m)
7	4.8	39
8	5.6	31
9	6.4	22
10	7.2	13
11	8	7
12	8.1	2
